North Coast Regional Water Quality Control Board

Inspection Report

Site: Gary VanDenBerghe, Mendocino County APN 056-170-10-00

Inspection Date: April 3, 2018

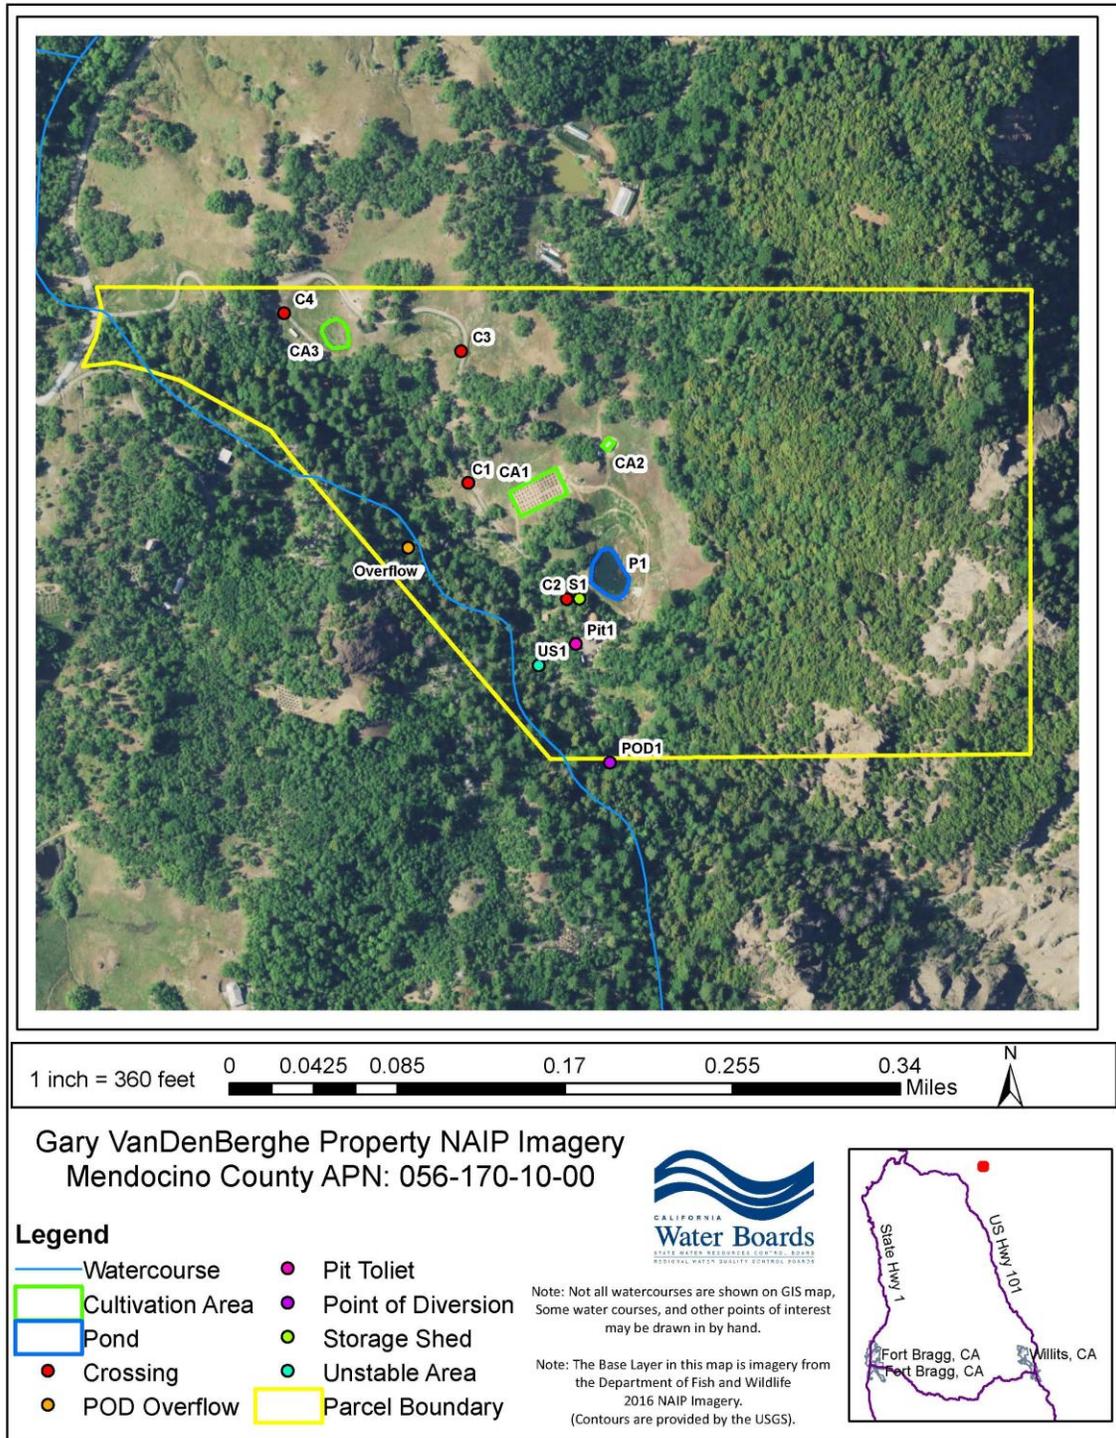
Figure 1 – Inspection points of interest

On March 7, 2018, I inspected the above-referenced property (Property), in the company of staff from the State Water Board's Division of Water Rights, and the California Department of Fish and Wildlife. The property owner, Gary VanDenBerghe, provided consent, but was not present during the inspection. The purpose of the inspection was to assist CDFW staff in their assessment of compliance with a proposed 1600 agreement and to assess compliance with the terms of North Coast Regional Board Order R1-2015-0023, under which the Property was enrolled. Figure 1, above, shows inspection points identified and discussed below.

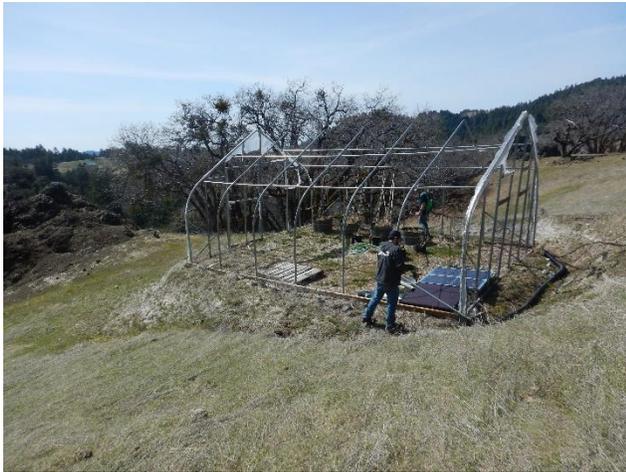
Photo 17 - CA1

During the inspection, I observed three cannabis cultivation areas throughout the Property, identified as inspection points CA1, CA2 and CA3. At CA1, I observed approximately 10,000 square feet of cultivation area, with signs of active cultivation (Photo 17). At CA2, I observed approximately 563 square feet of cultivation area, not apparently active (Photo 18). At CA3, I observed approximately 4,200 square feet of cultivation area, not apparently

active (Photo 19). I observed no water quality issues associated with any of the cultivation areas.
